OBSERVATIONS OF BREAKUP IN  
THE ATHABASCA RIVER BASIN  
UPSTREAM OF FORT McMURRAY, ALBERTA, 1984

**D.D. Andres, Civil Engineering Department  
Alberta Research Council**

**EDMONTON, ALBERTA  
REPORT NO. SWE 85/09  
NOVEMBER, 1985**

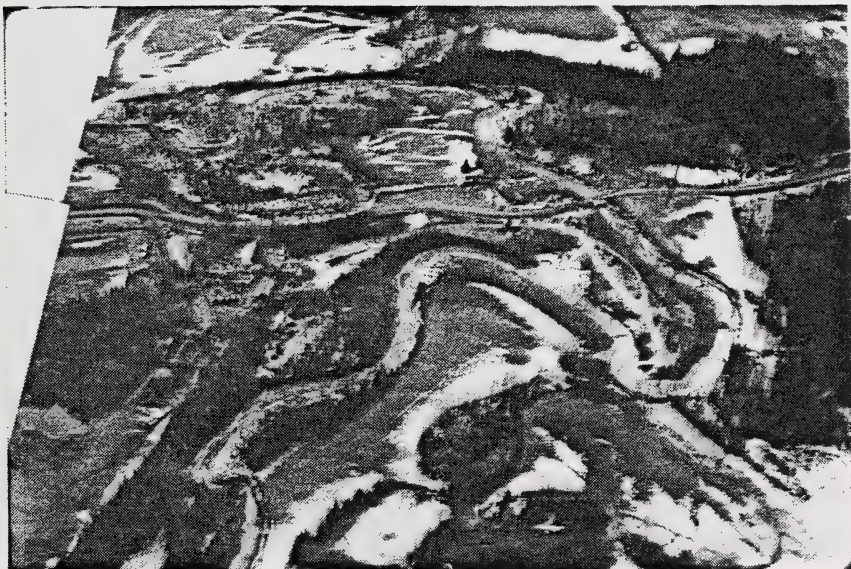
**Figure 10.** Intact ice cover on the Paddle River upstream of the Paddle River Dam, March 29, 1984

As expected, the Paddle River took slightly longer to respond to the melt even though releases from the partially completed dam at Rochefort Bridge may have affected the ice regime upstream of Barrhead. As of March 29, the ice cover upstream of the dam was still intact (figure 10) but some open leads had developed. The forebay of the dam

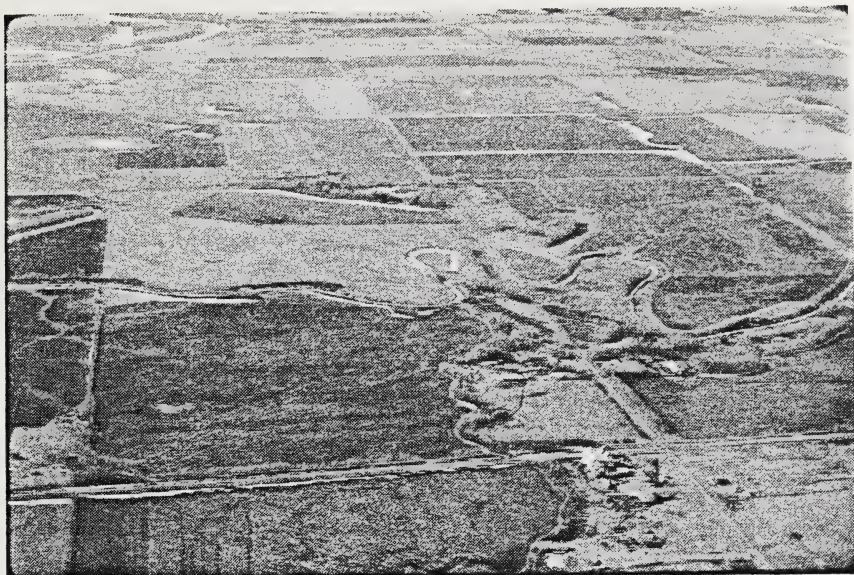
**Figure 11.** Solid ice cover on the Paddle River downstream of Barrhead, March 29, 1984

was ice covered but it appeared that releases of warm water from the dam had melted the ice cover downstream to within 8 km of Barrhead. This type of thermal breakup probably did not produce high water levels. Downstream of Barrhead, the cover was intact (figure 11) all the way to the Pembina River, although open leads appeared along the edges and some locally broken ice accumulated against the intact Pembina River ice.

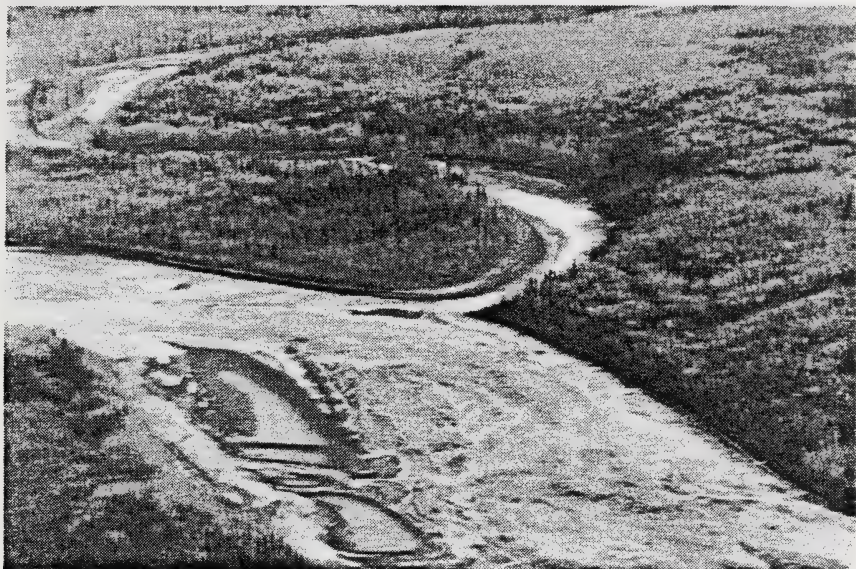
**Figure 12.** Intact ice cover on the Pembina River at Rossington, March 29, 1984

**Figure 13.** Intact ice cover on the Pembina River at its confluence with the Athabasca River, March 29, 1984

On the Pembina River, a solid cover was observed upstream of Sangudo on March 29. Most of the snow had melted and surface melting of the ice cover itself was taking place. The ice cover was intact and looked competent at Rossington, Jarvie, and all the way downstream to the Athabasca River (figures 12 and 13).

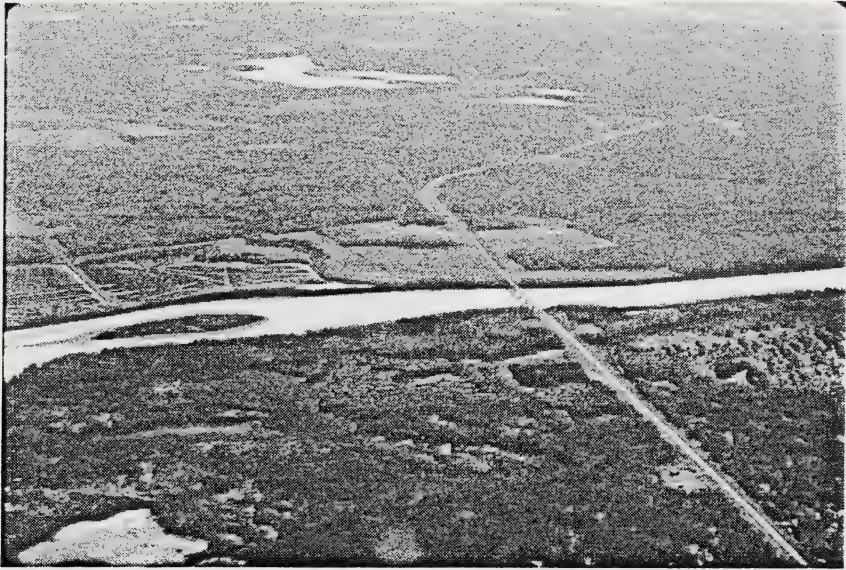
**Figure 15.** Solid ice cover on the Athabasca River at Hondo (km 806), March 29, 1984

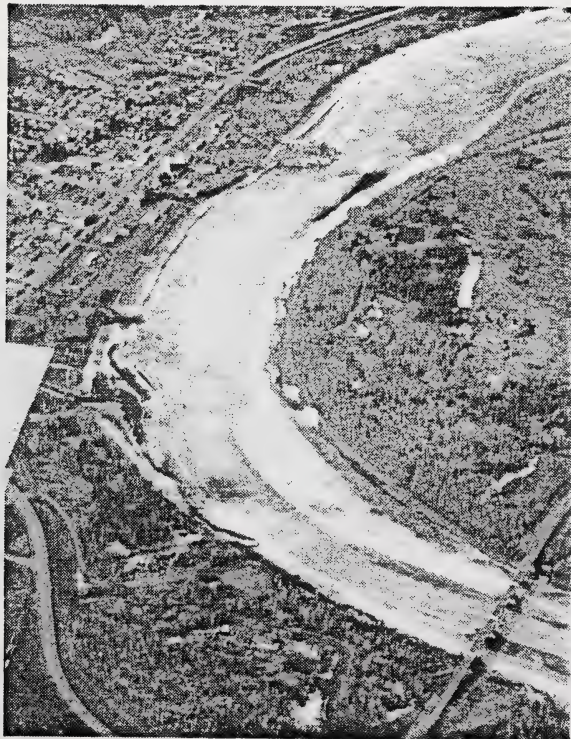
**Figure 16.** Intact ice cover on the Athabasca River at the Town of Athabasca, March 29, 1984

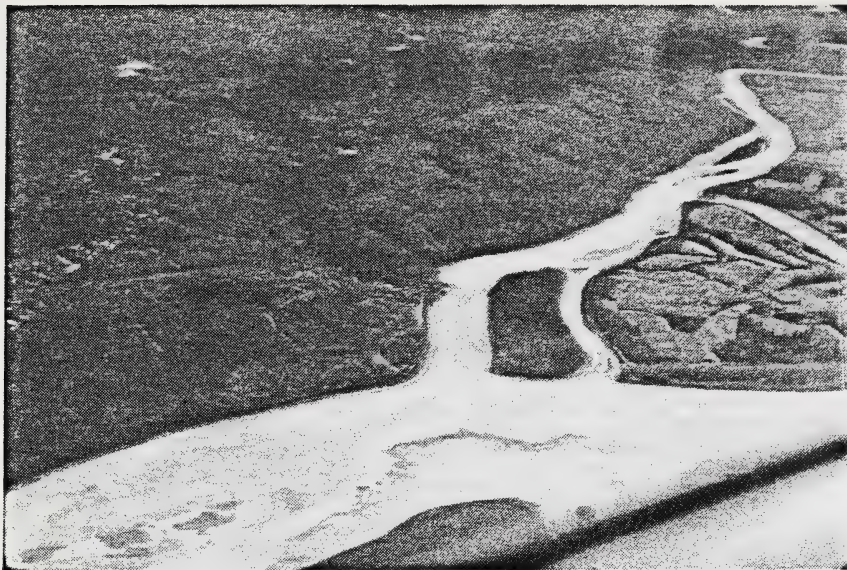
**Figure 21.** Solid ice cover on the Athabasca River at the mouth of the Clearwater River (km 293), March 29, 1984

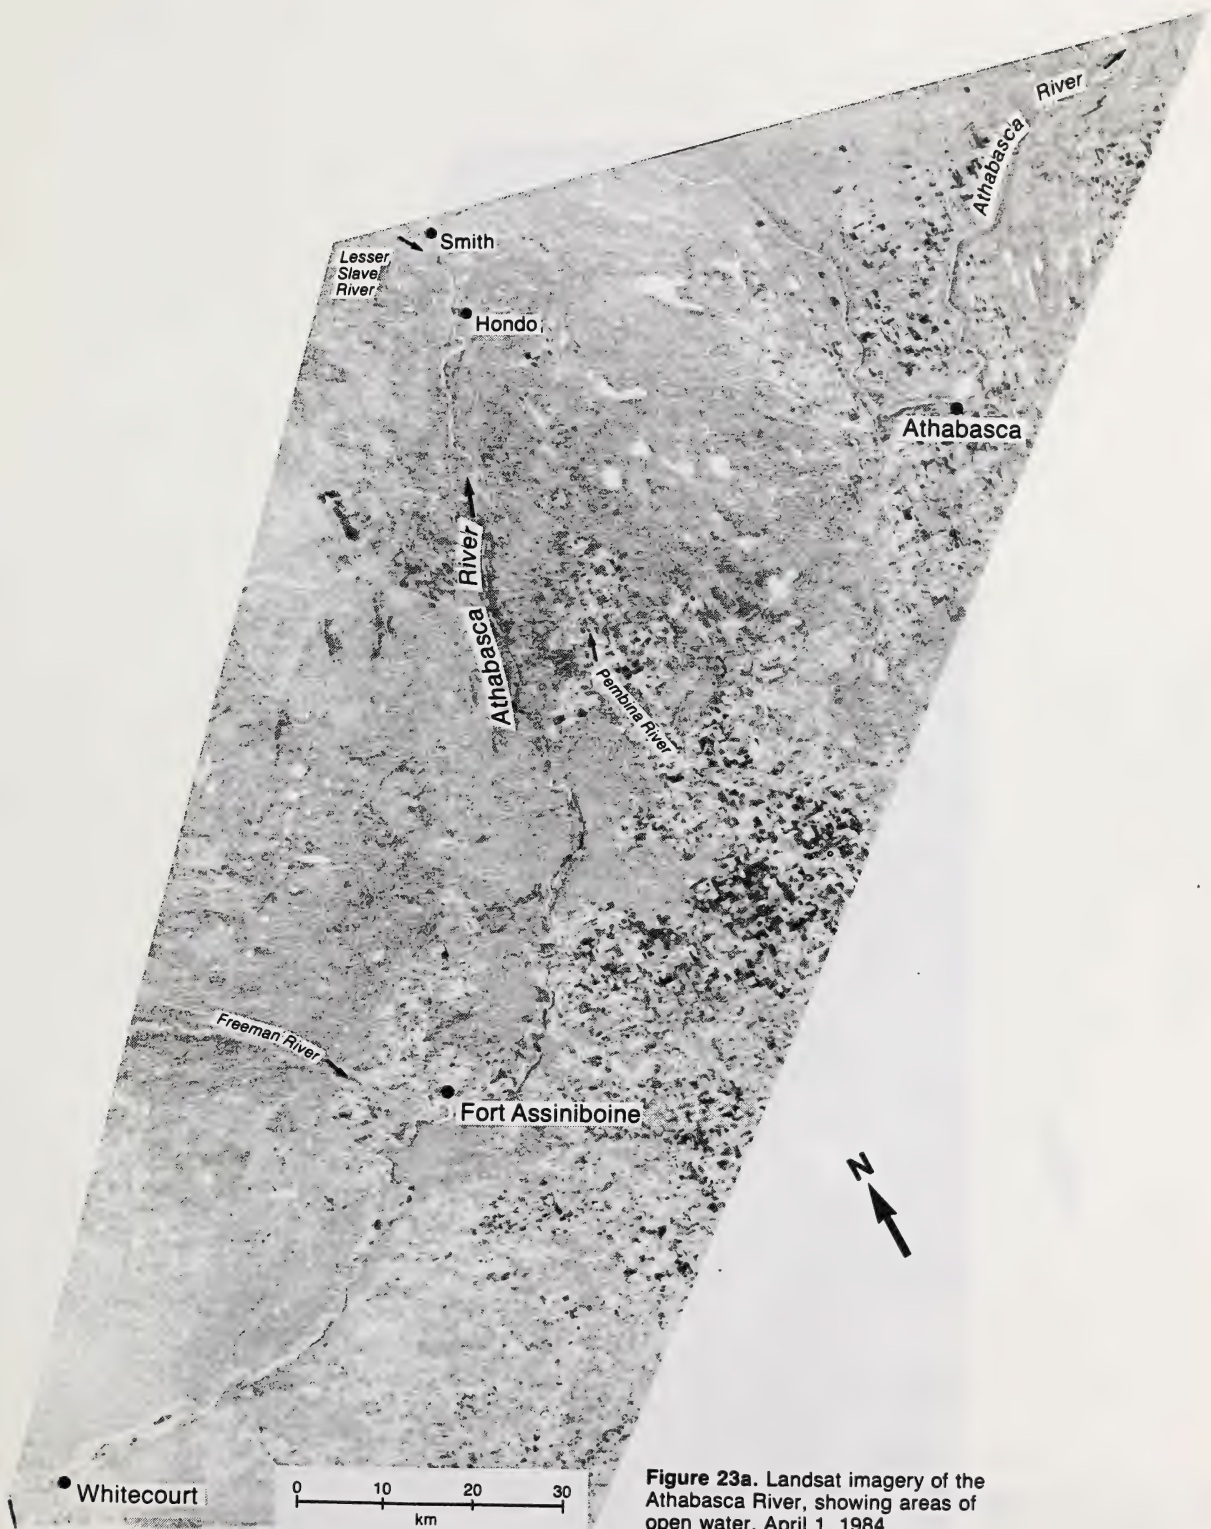
**Figure 23a.** Landsat imagery of the Athabasca River, showing areas of open water, April 1, 1984

Pembina River were both completely open. The Lesser Slave River was obviously ice free. Downstream of its confluence, the Athabasca River was essentially ice covered except for some open leads. From the Landsat imagery, the most obvious of these leads were located downstream of the Lesser Slave River, within Grande Rapids, in Boiler Rapids, in the vicinity of the Syncrude pipeline crossing (km 329), and downstream of the Suncor plant.

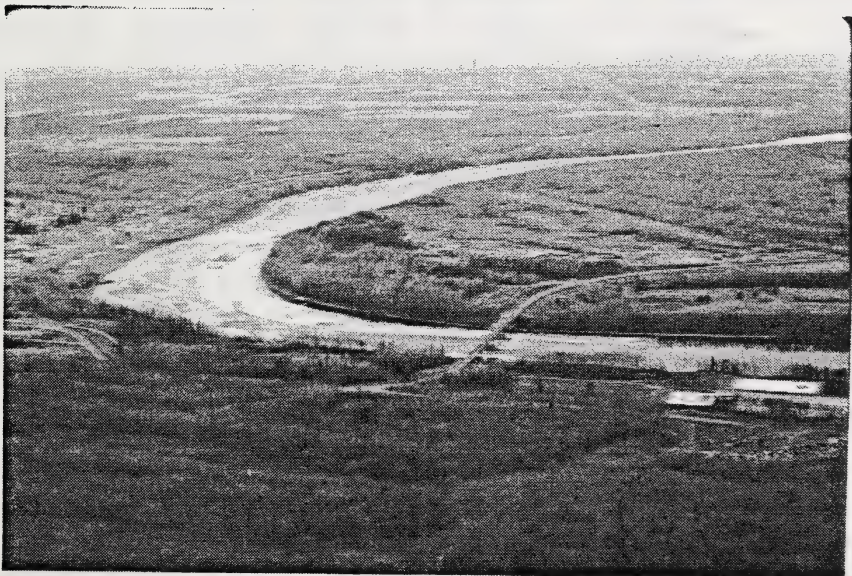
**Figure 25.** Deteriorating ice cover on the Athabasca River at the Town of Athabasca, April 7, 1984

Additional aerial reconnaissance on April 7 showed that the ice cover on the Athabasca River was intact, but approximately 80 percent of it had melted in place. This indicates that there was no stage increase to move the cover and break it mechanically. Instead, thermal forces were doing most of the damage (figure 24). Ice cover characteristics typical in figure 24 existed from the mouth of the Pembina River to the Town of Athabasca (figure 25). Downstream of Athabasca, to the mouth of the Calling River, considerably less open water was observed but the cover appeared to be deteriorating rapidly (figure 26). Observation downstream of the mouth of the Calling River had to be discontinued due to poor visibility.

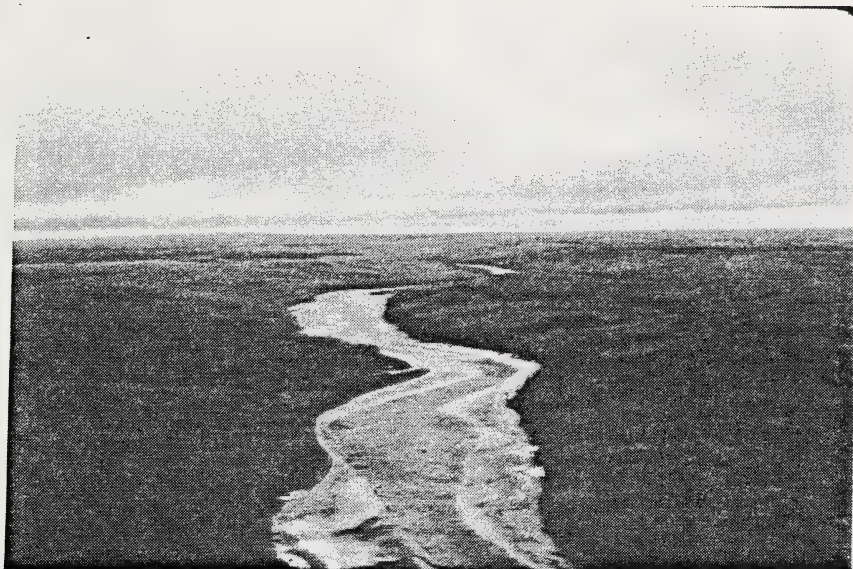
**Figure 26.** Intact, but deteriorating ice cover on the Athabasca River downstream of the mouth of the Calling River (km 610), April 7, 1984

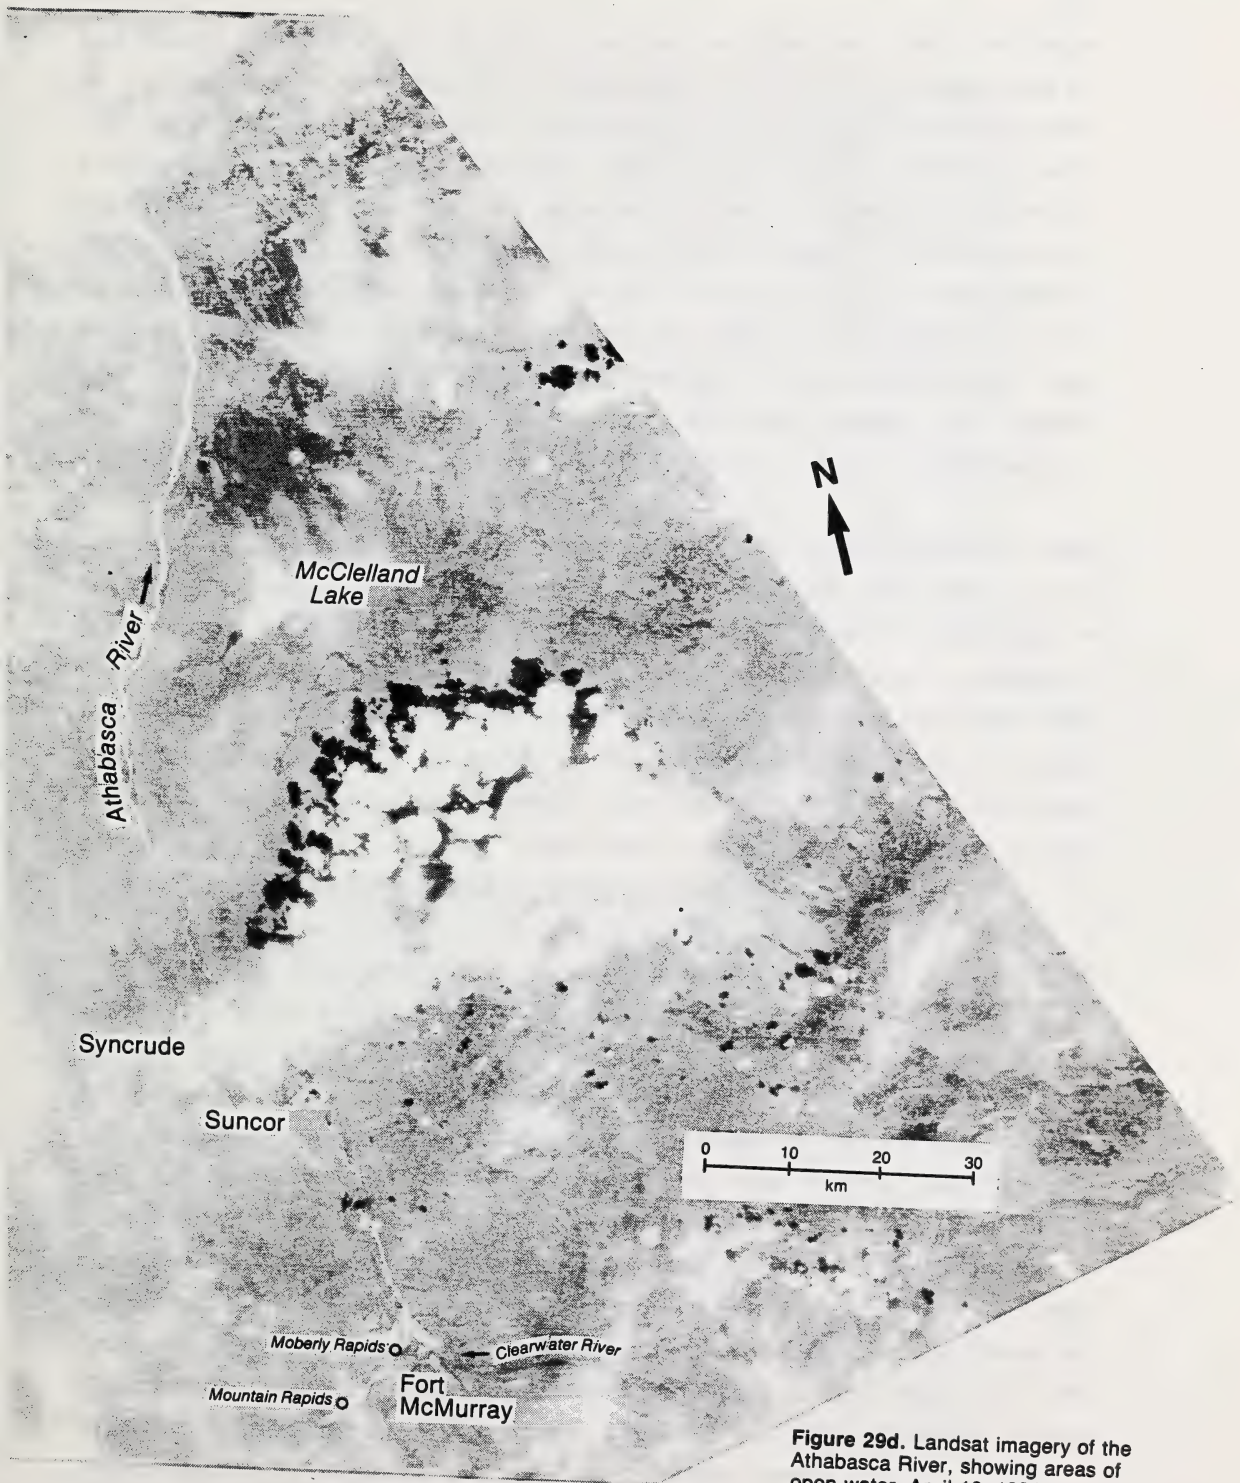
**Figure 29d.** Landsat imagery of the Athabasca River, showing areas of open water, April 10, 1984

River and Pelican Rapids on April 9 had moved downstream and filled up the channel between the mouth of the House River and Pelican Rapids (figure 29c, d).

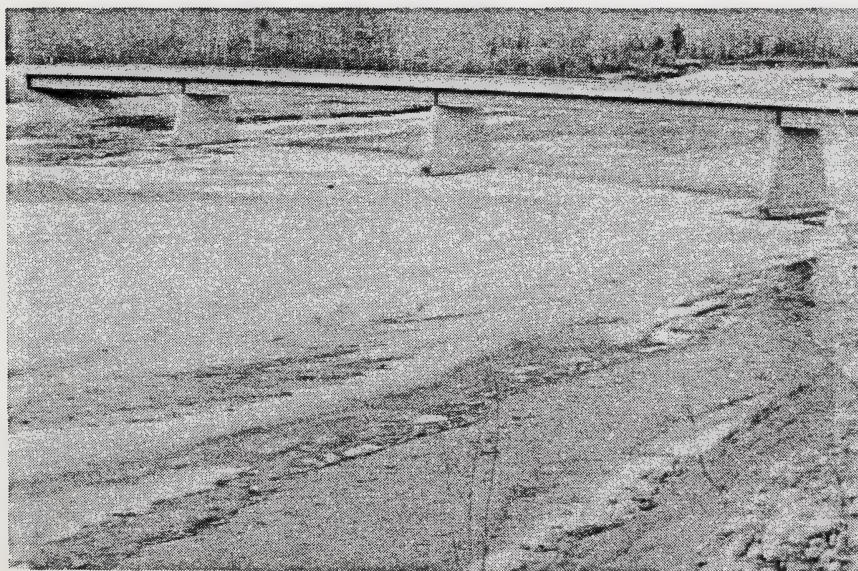
**Figure 37.** Solid ice cover with border melt on the Athabasca River at Blue Ridge, April 12, 1984

Following the observations of breakup at Fort McMurray, a quick reconnaissance was made of the ice conditions on the Athabasca River in the upstream parts of the basin. As of April 12, about eight days after breakup on the Pembina River and four days after breakup at the Town of Athabasca, the ice cover at Fort Assiniboine, Blue Ridge, and Whitecourt was essentially still in place. This condition existed even though there was about 90 C°-days of melting at Whitecourt and the ice on the McLeod River had gone out (figure 36). Obviously, the lack of a significant ice run on the McLeod River, as evident in figure 36, prevented the ice on the Athabasca River from being driven out. The result was a very solid-looking cover with only border melt evident at Blue Ridge (figure 37) and competent ice at Fort Assiniboine (figure 38).

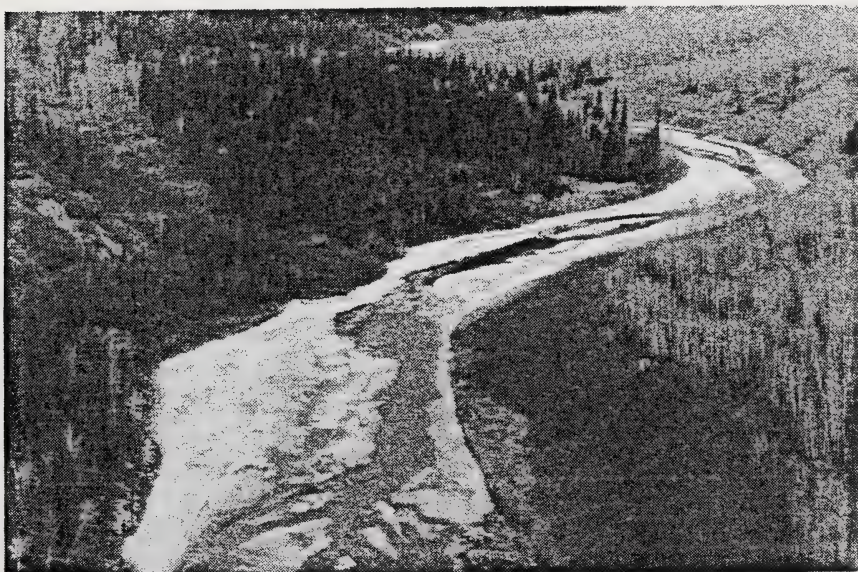
**Figure 39.** Deteriorating ice cover on the Christina River approximately 8 km upstream of the Clearwater River, April 11, 1984

As in most previous years the breakup on the Clearwater-Christina River system lagged behind that of the Athabasca River. Observations on April 11 indicated that the ice cover in the Christina River was intact due to the low runoff generated in the basin but considerable thermal deterioration had occurred (figure 39). The Clearwater River, on the other hand, was much more active and considerable open water was evident upstream of the mouth of the Christina River (figure 40) although at WSC Gauge #07CD001 at Draper, the majority of the flow was over the ice (figure 41). Gauge records, although discontinuous due to the malfunction of the gauging system, indicate that a significant increase in stage occurred at about 17:00 hours on April 12. It is not known whether this resulted from breakup on the Christina River or from incoming ice from the upper reaches of the Clearwater River.

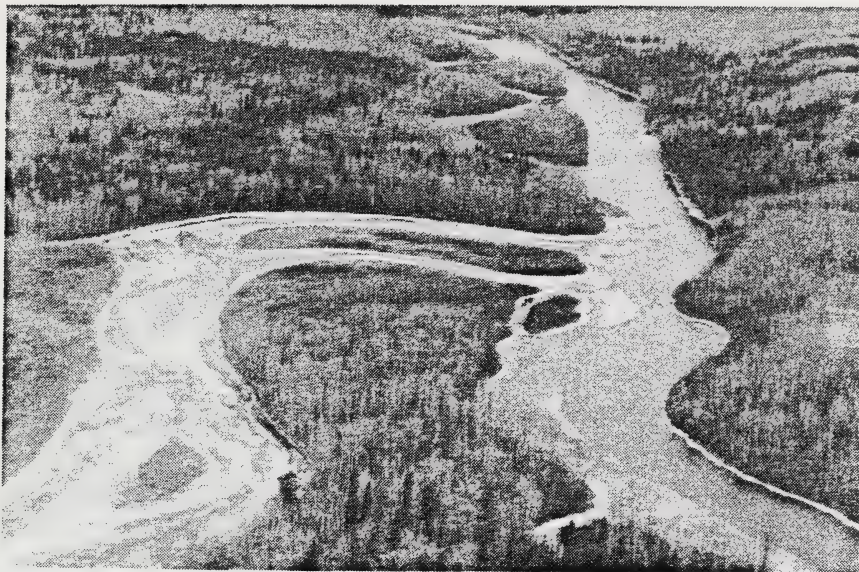
**Figure 40.** Open water on the Clearwater River at the mouth of the Christina River, April 11, 1984

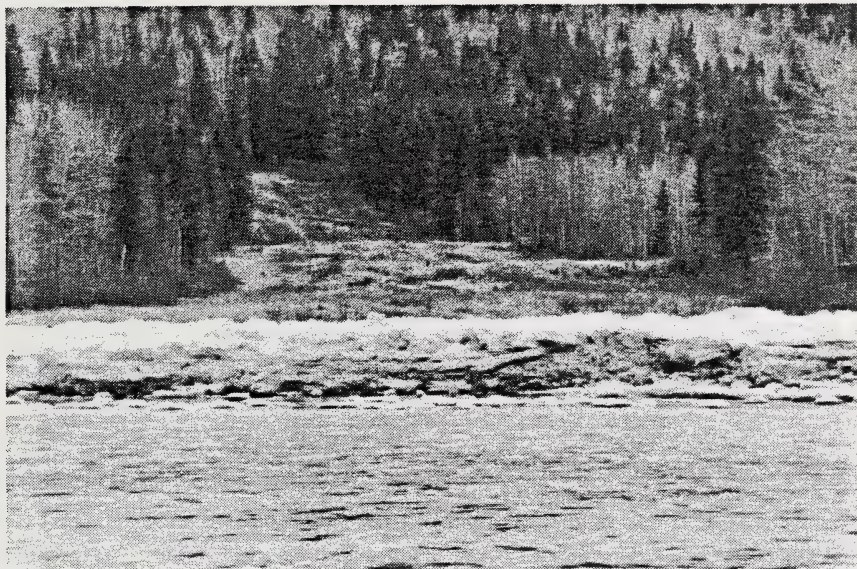
**Figure 45.** Shear walls resulting from the stabilization of the Moberly Rapids jam

From the shear wall measurements (figure 45) it was apparent that the jam was the thickest near the downstream end of its equilibrium portion, where the shear wall thicknesses varied between 4 and 5 m (figure 43). At the upstream end of the equilibrium reach the shear wall thicknesses were estimated to be in the order of 3 to 4 m. Overall the average minimum thickness of the jam was estimated to be 4.1 m.

There are some alternatives to the above, but all involve some limiting assumptions. Firstly, one can assume the thickness of the cover is reflected by the unsubmerged thickness of the shear walls. This results in a higher estimate of the roughness and the dimensionless coefficient at internal friction. Second one can assume that all of the observed jams on the Athabasca River in the Fort McMurray area have similar roughness and use an ice roughness of 0.072 as reported by Andres (1980) and Andres and Doyle (1984). One can then go on to compute the thickness and the subsequent dimensionless coefficient of internal friction.
